# Claims experience for Lorca, 11 May 2011

## Alfonso Manrique Ruiz

Deputy Director for the Expertise Department (1988-2021)  
Consortio de Compensación de Seguros

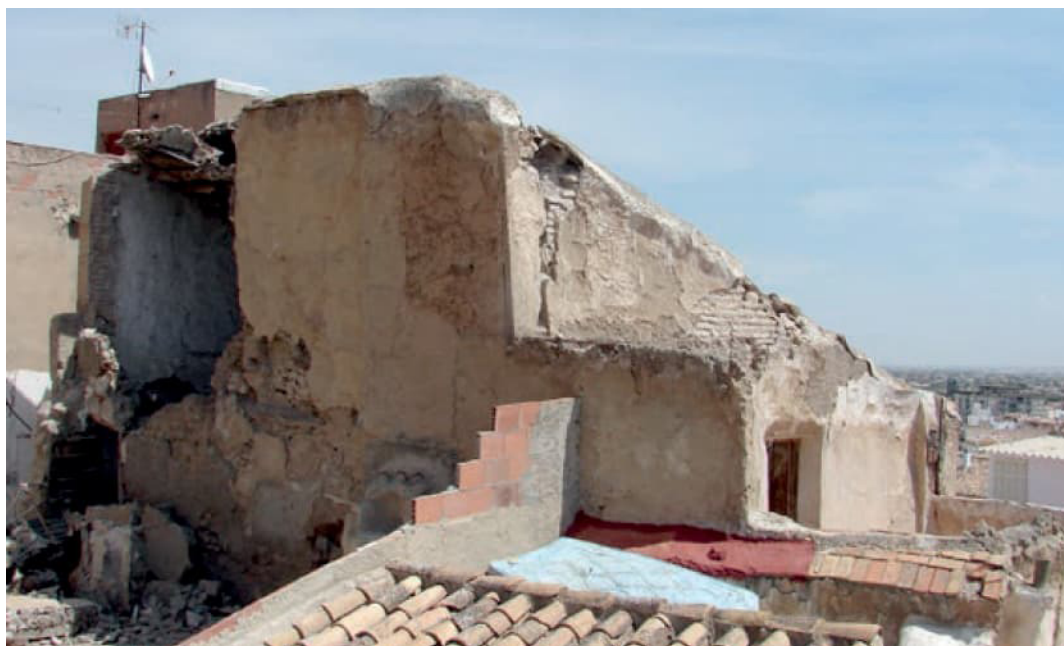
In the old part of the city there were many homes that had rooms located in the building on the adjacent plot of land, which had at one time been split up, which gave rise to a whole set of problems when it came to justifying the actual insurance coverage for such abodes or rooms. The quandary also arose of illegal structures or unlawful extension of areas where building is allowed, such as on terraced roofs .

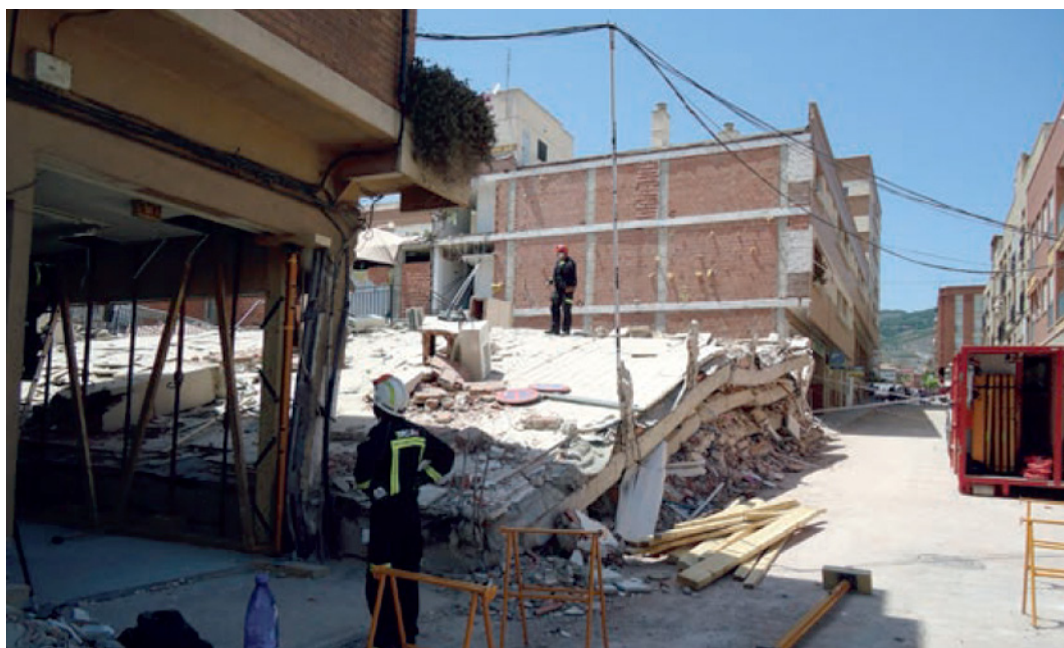
On 18 May 2011, seven days after the earthquake event, Lorca Council made a start on demolishing the first building, the “Princesa” residential community comprising numbers 57, 59 and 61 on the Granada road.
