The Lorca earthquake: Lessons for reconstruction

Ramón Cabal Álvarez

INTEMAC, Universidad Politécnica de Madrid

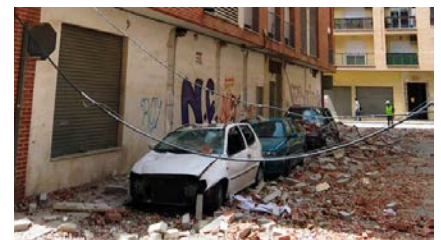
(Photograph nº1)

As a direct result of the quakes, especially the second (with a higher magnitude than the first), many architectural elements, including roof parapets, façade panels and store front enclosures, fell off of buildings and onto the street (photograph 1). All the mortalities and the vast majority of the injuries were due to the impact of falling rubble.

As a direct result of the quakes, many architectural elements, including roof parapets, façade panels and store front enclosures, fell off of buildings and onto the street. All the mortalities and the vast majority of the injuries were due to the impact of falling rubble.

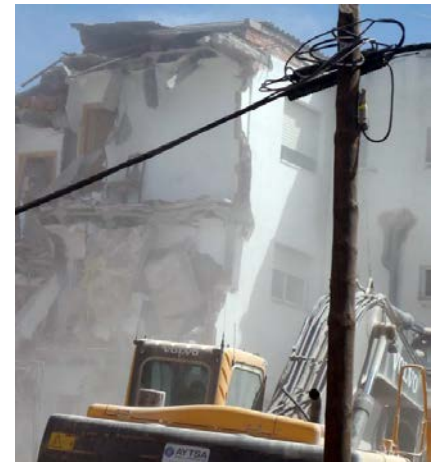
(Photograph n°2)

Only weeks later, a large number of buildings were earmarked for demolition (photograph 2). Since many of the buildings affected were positioned side-by-side, the appearance of some neighbourhoods was soon substantially altered by the presence of vast empty lots.

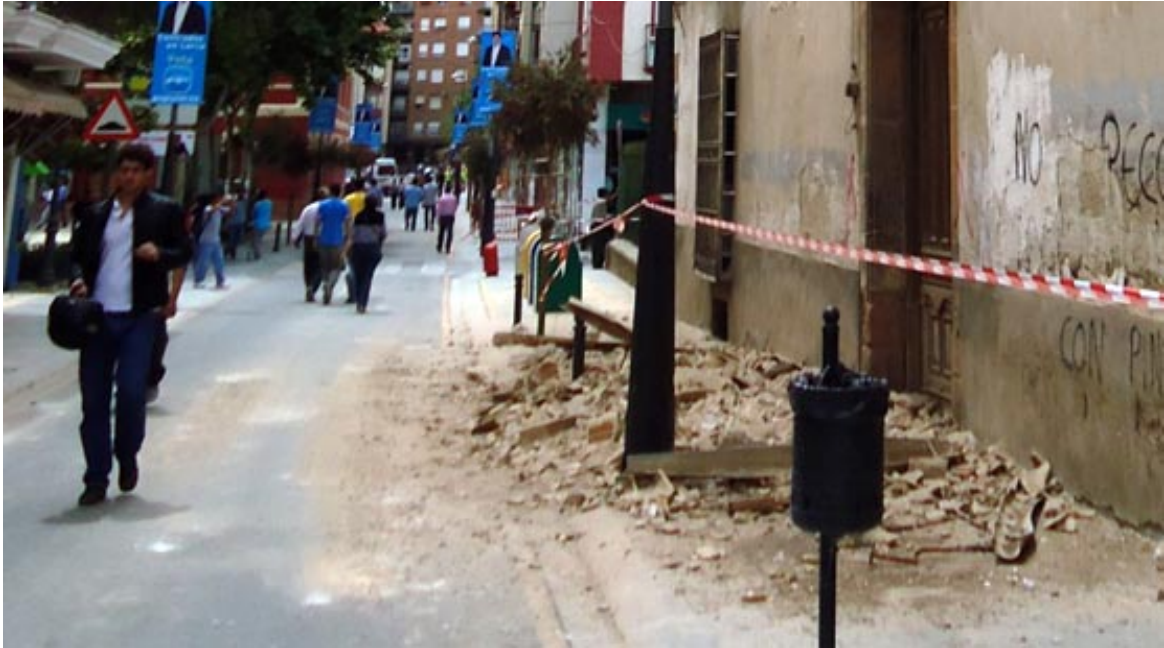
Photograph nº3

Many streets were bustling with people, as shown in photograph 3. In others, people sat resting on sidewalk cafés... occasionally alongside masonry façades whose stability was precarious at best.

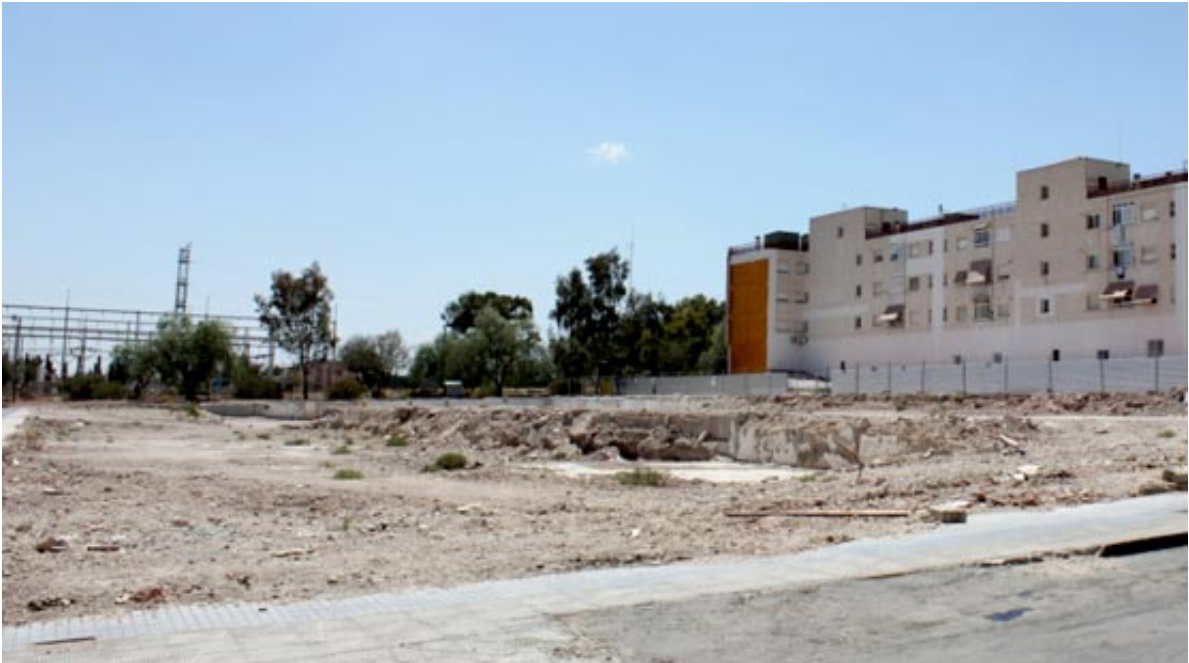
Photograph n°4

The fate of many of the buildings in Lorca was cast just a few weeks after the quake, and in a matter of months whole city blocks were demolished (photograph 4), leaving certain quarters of the city woefully bare.

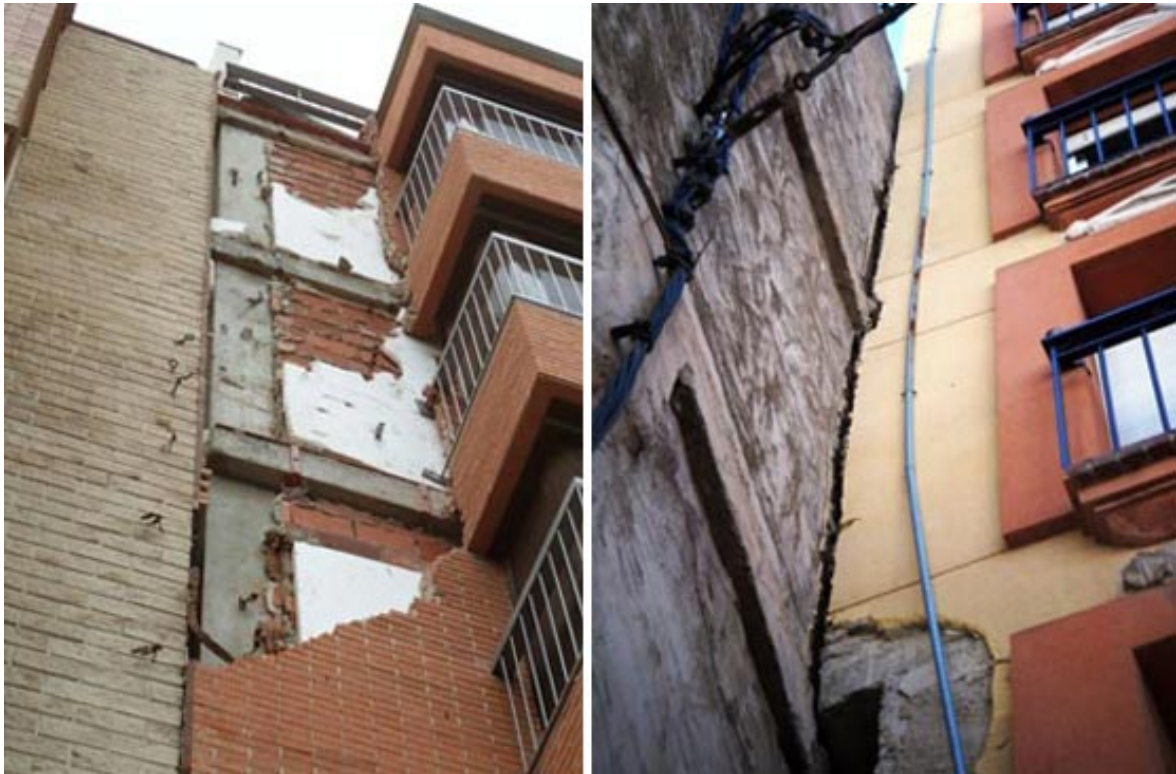
Photograph nº5-6

A simple example may illustrate this idea. All our cities are organised around a similar pattern: buildings are grouped by blocks flanked by streets whose uniform fronts characterise our urban scenery. Each new building is erected alongside the existing ones, while the successive editions of earthquake-resistant construction codes have failed to impose the minimum space necessary to prevent pounding between adjacent buildings or even between their façades. The result is severe risk of collapse of whole panes of masonry (photograph nº5) if a quake does strike.

Theoretically, Spain's fairly moderate seismicity would allow for intermediate solutions, maintaining the formal continuity of street fronts while at the same time leaving the space required to ensure each building's independent response to earthquakes. In practice, however, this is a matter that not only remains unsolved, but in fact is not even addressed: each new building is built directly against the one standing adjacent to it (photograph nº6)

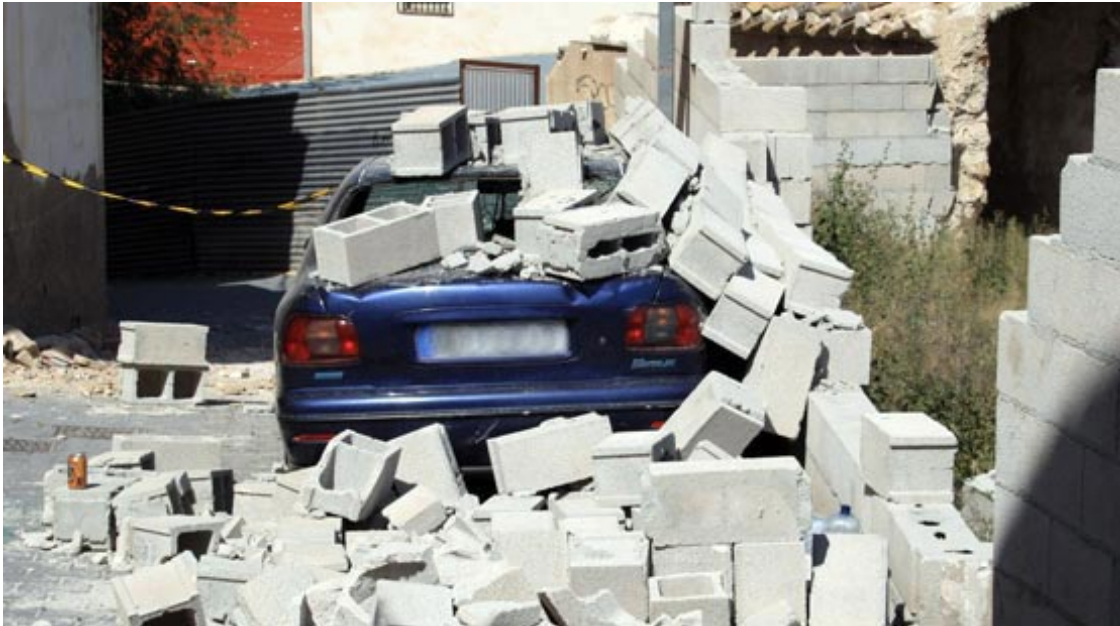
Photograph nº7

Urban planning ordinances, in turn, seldom regulate specific matters not included in higher level legislation. While structures such as property walls (photograph nº7) are often a municipal requirement, local ordinances fail to establish reasonable construction solutions that would prevent their collapse during an earthquake. Such walls are frequently built with heavy masonry that constitutes a high risk not only under accidental loads, but even when exposed to simple wind action.

While the country is obviously not in a position to require formal architectural designs to guarantee the safety of walls around each and every property (standard procedure in other countries), the number and severity of the incidents involving these walls (particularly during wind storms) are alarming. The collapse of a wall of this nature caused a mortality in the Lorca quake.

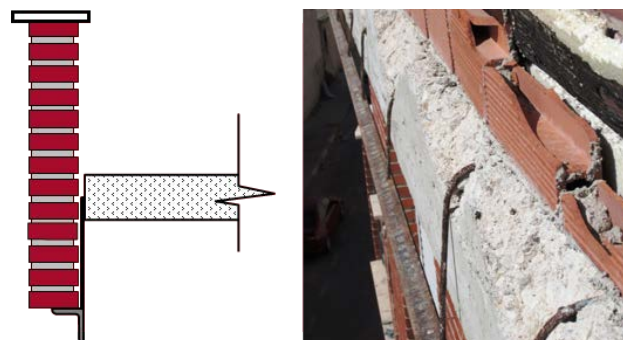
Figura nº 3 y Fotografía nº 8

The sole variable in the standard construction arrangements in Spain shown in Figure 2 is the position of the masonry with respect to the floor slab. Since the nineteen fifties when the panes rested fully on the slab (Figure 2 A), other solutions have been developed, such as the partially supported façades (Figure 2 B) often seen today, and attachment to steel brackets (Figure 2 C). A variation on the third approach, very common when the pane is not upwardly continuous, consists of securing the bracket to rods hung from the floor slab (Figure 3 and photograph 8)

This wholly inappropriate solution, unable to resist any horizontal action, was used in many of the roof parapets that collapsed during the Lorca earthquake. The severest problem, however, is that this is not the only hazard.

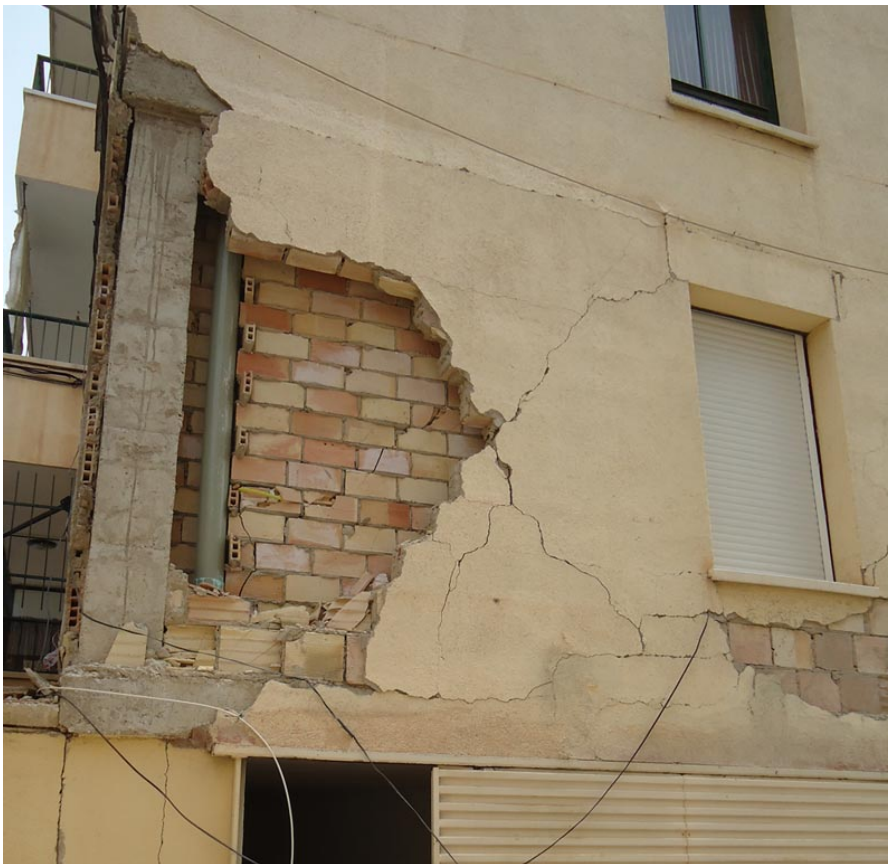
Photograph nº9

That, of course, leads to structures that are so flexible that, as the Lorca experience showed, they bear absolutely no load because stress is supported by the much stiffer enclosures and partitions.

Among many other problems, this approach clearly entails forfeiting the ability to control damage to partitions and enclosures (photograph 9).

The new code will presumably delimit such excesses by imposing some manner of ceiling on relative inter-storey displacement, a provision in place for many years in other countries.
