Loss adjusting for cultural heritage assets in Spain for Consorcio de Compensación de Seguros

Rosa Gallardo, TAV Arquitectos **Mª Esther Cocho** Architects

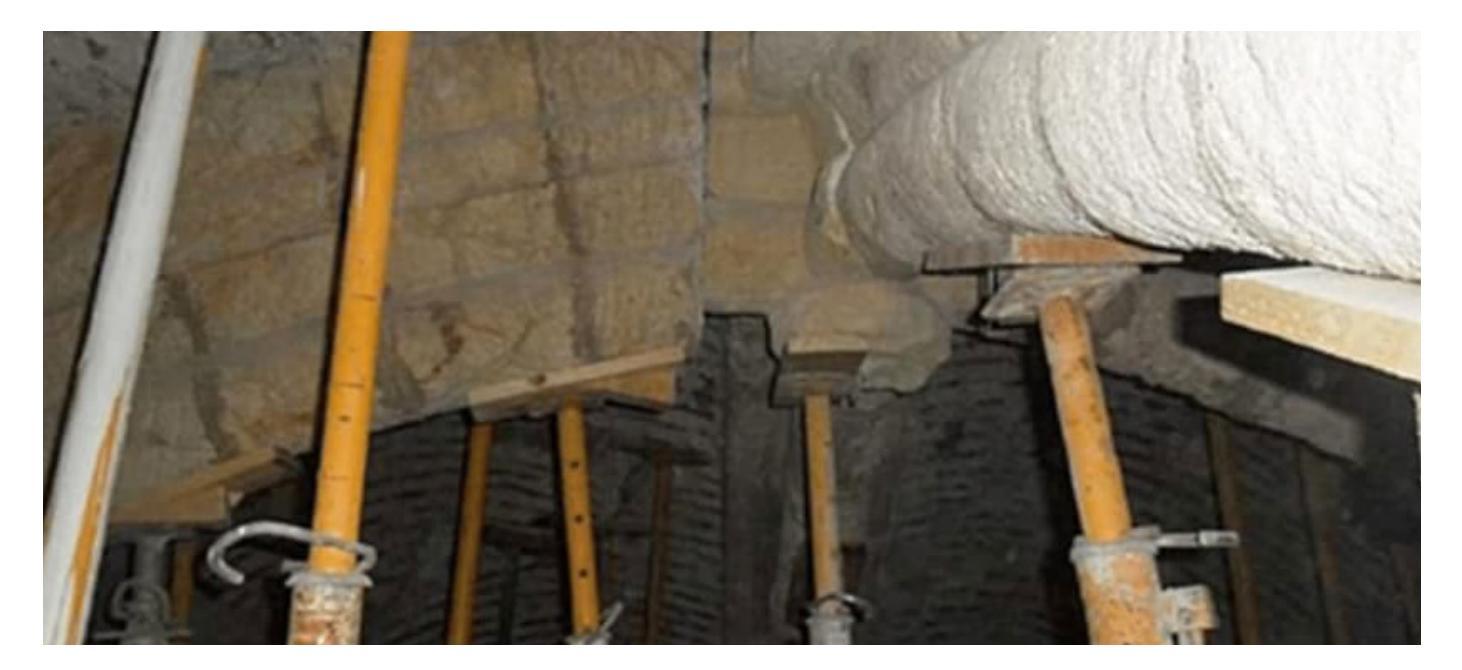
Figure 1¹. Photograph of the interior of the Espolón Tower [Tower on the Spur] of the Castle in Lorca after the 2011 earthquake.

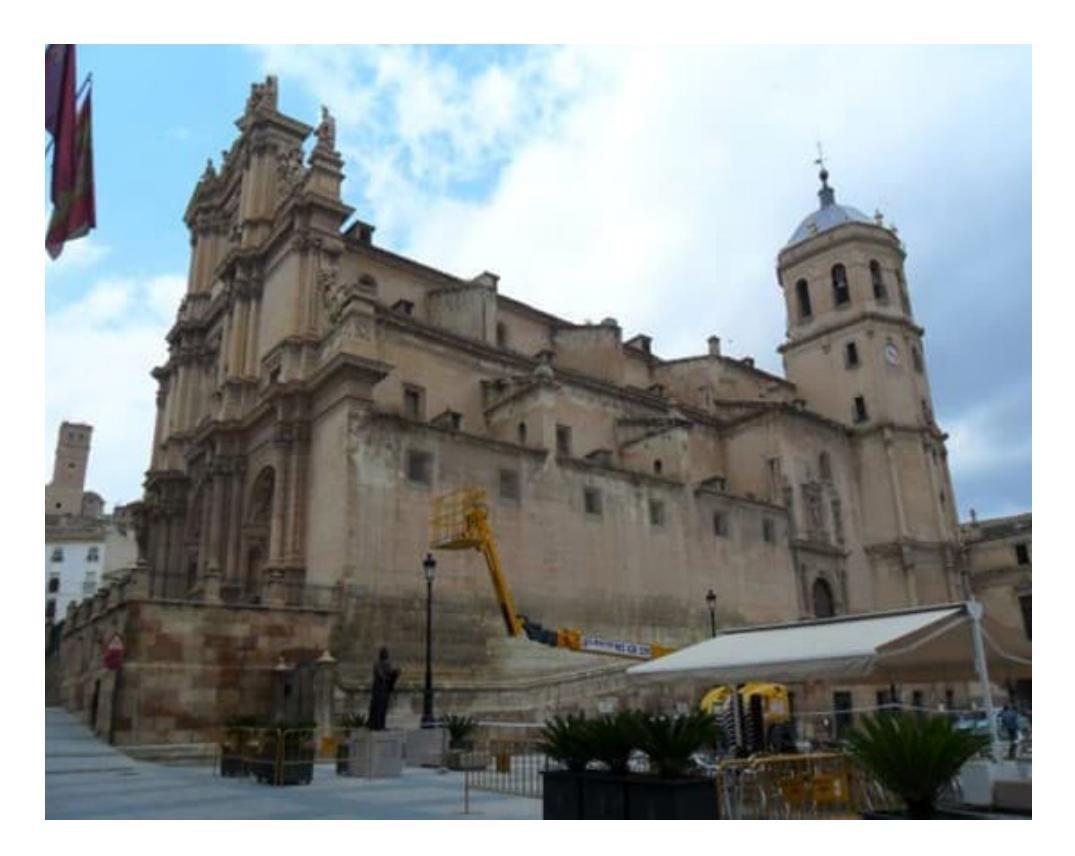
Figure 2. Photograph of the former Saint Patrick's Collegiate Church showing one of the cranes used to remove elements from the upper portions on the building that were at risk of falling.

Since the building was a severely damaged BIC, repair work was started right away. Initial emergency work removed all the elements at risk of falling with the help of cranes. The owner hired a firm that specialised in restoring⁵ and renovating artistic and historical heritage to do the emergency work under the supervision of technical teams from the Ministry of Culture, the Murcia Regional Government's Office of Fine Arts and Cultural Assets, and the Lorca City Council.

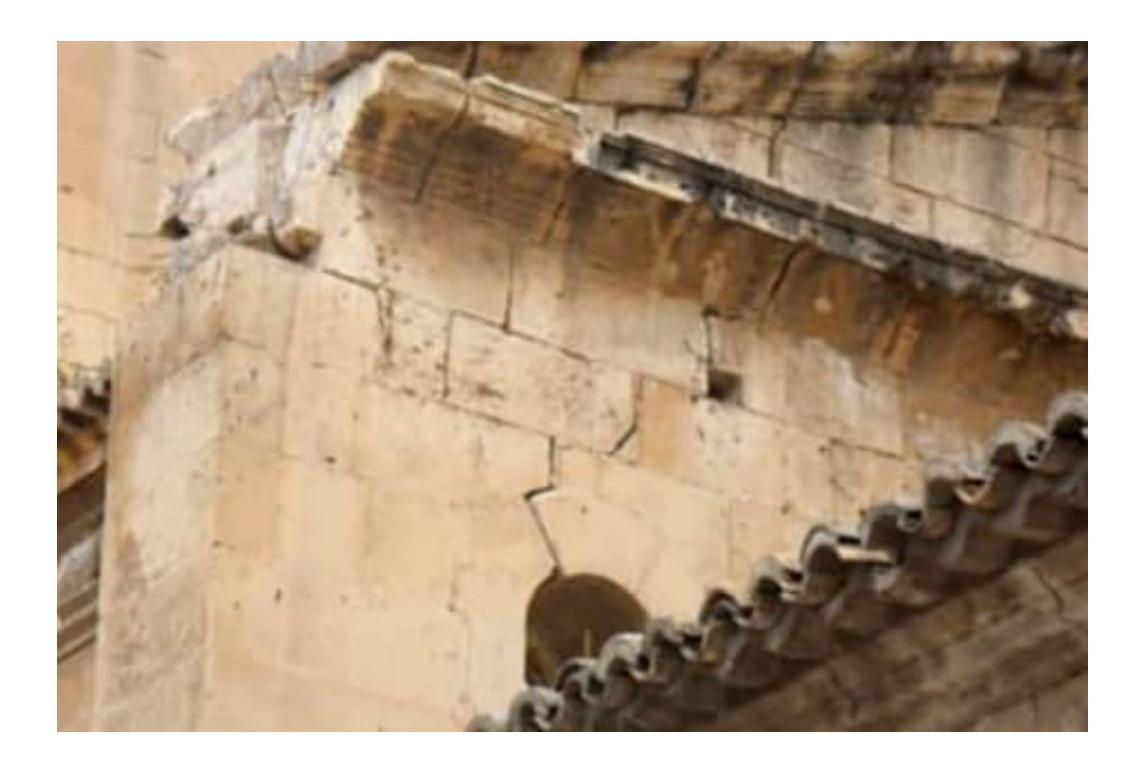
Figure 3. Photograph showing damage plainly visible from the exterior. The pinnacle on the end of the buttress and part of the cornice have collapsed. There is a crack over the arch located in the wall section of the buttress itself, and the keystone has dropped down. Plants can also be seen to be growing on the roof, an indicator of inadequate maintenance.

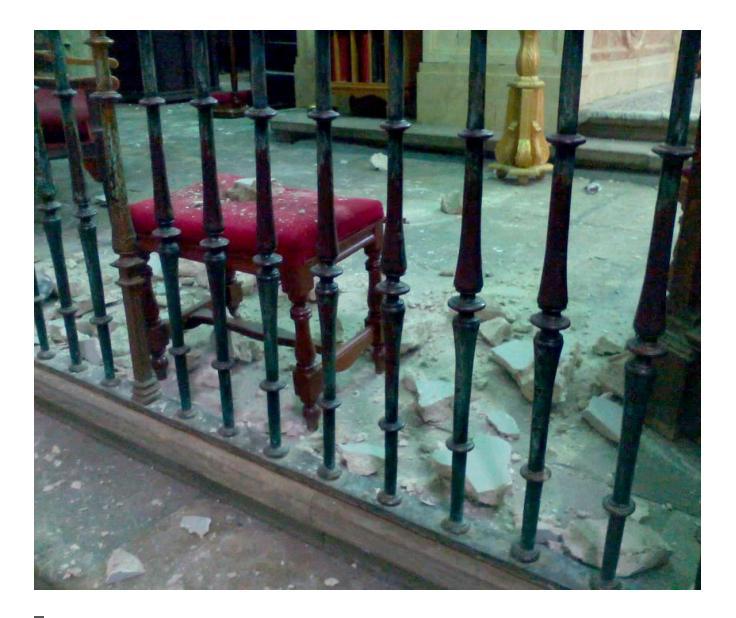
There were also details about the loss, since the mass media had quickly taken up this news story. Photojournalism reports showed debris on the ground, indicating that we would find fallen masonry cladding materials and fissures in arches and vaults.

Figure 4. Fallen masonry cladding in the Santa Fe Parish Church of the Incarnation. These can be seen to be quite thick, typical for buildings of this kind.

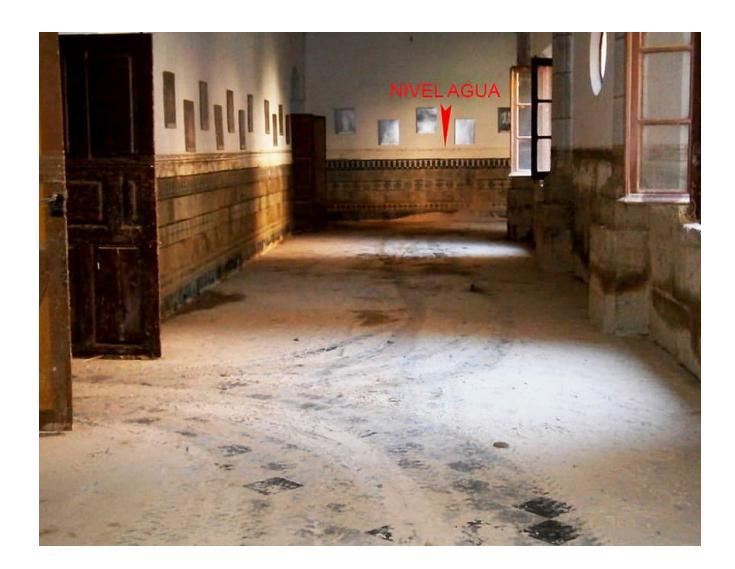
There was damage to vertical masonry facing elements (traditional aggregates, wooden plinths), wood floors, woodwork (wooden doors and windows, stained glass windows), electrical systems, furnishings (benches, pedestals). In contrast, the walls and floors, made of stone, were only soiled.

According to information contained in Olite's 2020 Municipal Emergency Flood Risk Plan, this was not a unique event. There had been a number of major floods, e.g., in 1353, 1664, 1795, and 1943. This demonstrates the effect of location of the risk on the occurrence of losses of this kind.

Figure 5. St. Francis' Convent. Accumulation of mud on stone walls and floors and damage to wall cladding, paintings, and woodwork.

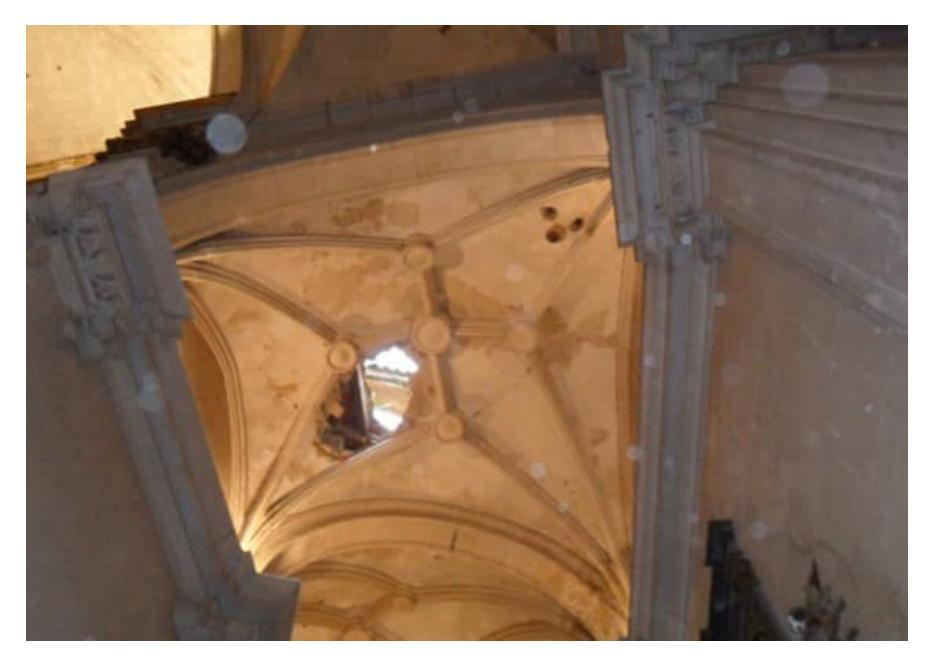
Coming back to previous examples, **St. Patrick's in Lorca**, struck by an intensity VII earthquake, suffered damage to structural elements (walls, buttresses, vaults, and roofs) and non-structural damage to decorative elements. This damage can be summarised as the appearance of cracks in vaults and arches discharging onto the tops of walls; separation of the vaults in the side arches of the ambulatory; large cracks in the outer and interior walls and in the compartments of the vaults; collapse of the cladding covering the ashlars in the ambulatory; descent of the keystones in nearly all the interior arches in the buttresses and toppling of pinnacles, eaves, and stone blocks of the tower, the top portions of the buttresses, and the ambulatory, in turn producing holes in the roof and in several vaults. The stability of a number of other elements (pinnacles, eaves, and stone courses) was affected, some were twisted, and others partially toppled. The construction, the structure of buttressed load-bearing gravity walls, proved to be sufficiently solid and deformable, so none of the structural components collapsed.

Figure 6. Former St. Patrick's Collegiate Church. Plainly visible damage in the interior. Hole in the double curvature vault.

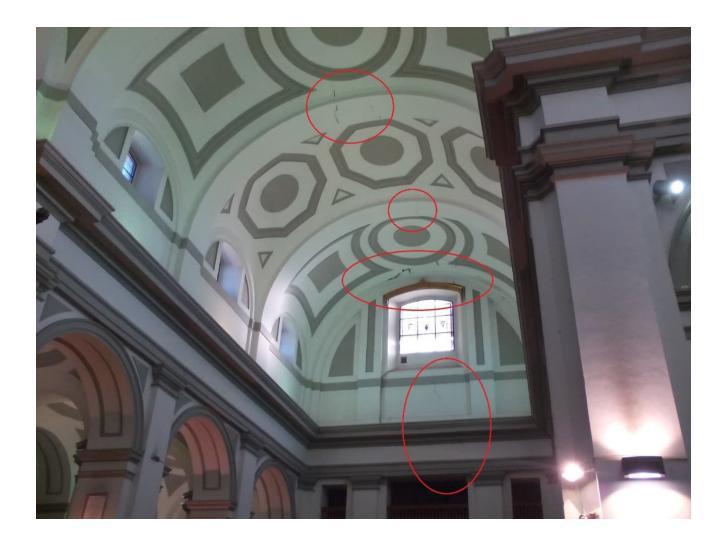
By contrast, the damage caused to **the Parish Church in Santa Fe** by the maximum intensity V quake was just cracks in the veneers crossing vaults and domes running in a clear lengthwise direction; cracks in the cladding over the lintels, the keystones of the arches, and walls; cracks in between the ribs and vaults; fallen cladding; fallen mouldings from cornices; and shifting of lintel stones. Brickwork and stone pillars suffered very little damage.

As in the church in Lorca, the location and pattern of the affected areas was indicative of horizontal displacement. The defects were similar in nature but less severe.

Figure 7. Parish Church of the Incarnation in Santa Fe. Longitudinal cracks in the claddings of domes, vaults, arches, and vertical walls.

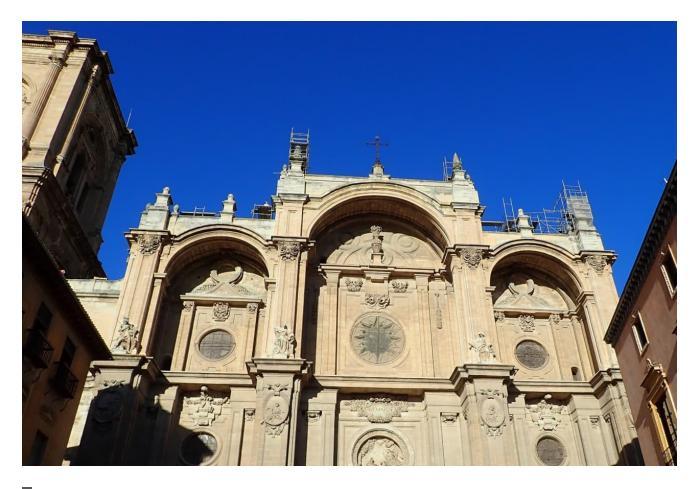
Let us consider the effects of lower intensity tremors by looking at another example. In the environs of the **Cathedral in Granada**, the tremors had a maximum intensity of IV, which according to the EMS-98 does not result in damage. And indeed, there was no damage to architectural elements, yet even so the event was not completely without any effect at all. Stone fragments from ornamental elements on the façade affected by the ravages of time were knocked down into the street. This made it necessary to take safety measures and carry out costly emergency work to stop accidents from happening.

Figure 8. Granada Cathedral. Auxiliary emergency measures, removal of ornamental elements from the façade.
