CO∩SOF∕DEQUEOS
 Number 16 | Spring 2022

Flooding in Navarre, the Basque Country, Aragon and Burgos, 2021

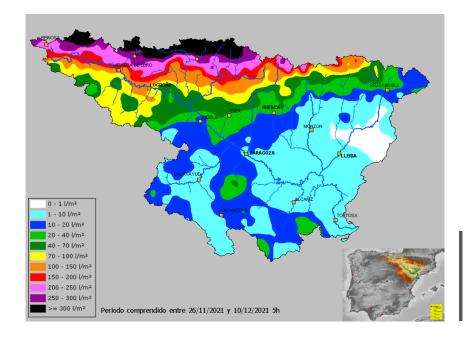
Figure 1. Rainfall recorded in the Ebro basin between 21 November 2021 and 10 December 2021.
Source: Ebro Hydrographic Confederation.

Over November and December 2021 there were frequent rainfalls in the catchment area of basins. To cite a few examples, in Balmaseda (Biscay) 150 mm were recorded between 27 and 28 November; in Pamplona it rained for 15 straight days (from 22 November to 7 December) and more than 215 mm fell; and from 9 to 10 December figures approaching 175 mm were registered in Añarbe (Gipuzkoa) and Gorbea (Araba), and over 200 mm in areas of the Pyrenees and on the Cantabrian side of the watershed.

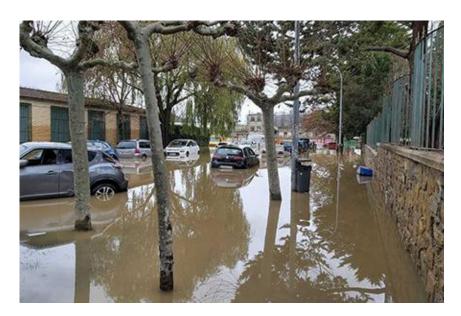
Figure 4. Overflowing of the river Arga in Burlada near Pamplona. Source: CCS.

Two events can be distinguished for the period under review. Heavy rainfalls in late November which caused several floods and then another event in mid-December featuring the combined effects of a sudden thaw due to sharply rising temperatures and persistent rainfalls in the northern part of the Ebro basin. All of this led to flows moving to river basins, which initially affected the Ebro at the point where it passes through Miranda de Ebro (Burgos), with alerts for extraordinary surging of the rivers Trueba and Nela in Burgos, and the Arga and Ega in Navarre, with the flooding ultimately arriving at the mid-section of the Ebro. The basins of the Bidasoa, Oria, Deva and Urumea, running into the Bay of Biscay, were also affected. Against this backdrop the river Arga recorded one of the highest figures in its historical dataset with a flow of up to 524 m³/s where it runs through Pamplona.

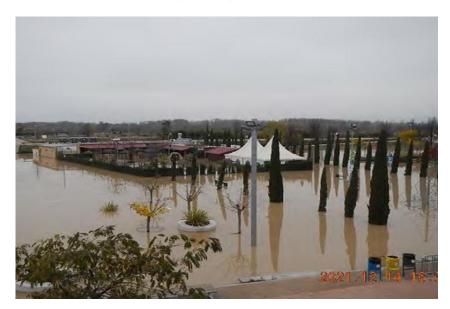
Figure 5. Flooding at the Water Park in Zaragoza. Source: CCS.

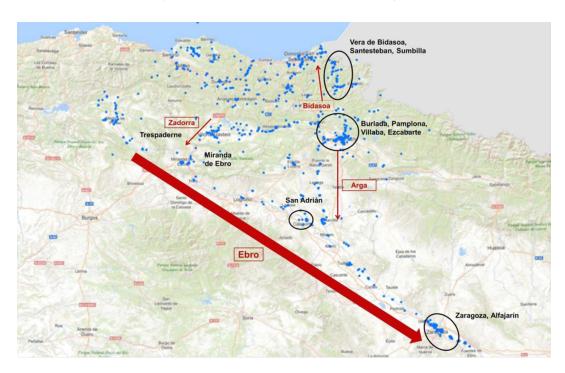
Figure 6. Geographical distribution of claims files and direction of river courses. Source: CCS.

Handling these claims was characterised by being a new episode of the river Ebro and its tributaries bursting their banks, which was yet another among those that have taken place in the past 10 years. Moreover, two types of situations arose simultaneously: on the one hand, communities in Navarre experienced a high number of losses due to the extraordinary volume of flows along the rivers Arga and Ega (among these, we might cite Burlada, Pamplona or San Adrián as examples), and on the other hand there was a broad scattering of losses in other municipalities where, although serious damage occurred to housing developments or facilities close to the Ebro, generally speaking the losses were relatively smaller and very widely spread out along the basins. The time of year when these floods happened was also an influential factor. The drawing to a close of the irrigation and watering season and the fact that this took place in the first quarter of the hydrological year meant that the reservoirs had substantial available storage capacity, which brought about very significant diminishment of the effects of the rises in water levels. On this occasion, for example, according to figures from the Ebro Basin Authority the Yesa and Itoiz reservoirs (on the rivers Aragón and Irati) each at certain times held up peak flows of over 700 m³/s (more than the highest volume of flow running through Pamplona for the Arga during this episode). Furthermore, it is relevant here that the soil's drainage capacity was still below the level of aquifers, such as in the middle Ebro valley.

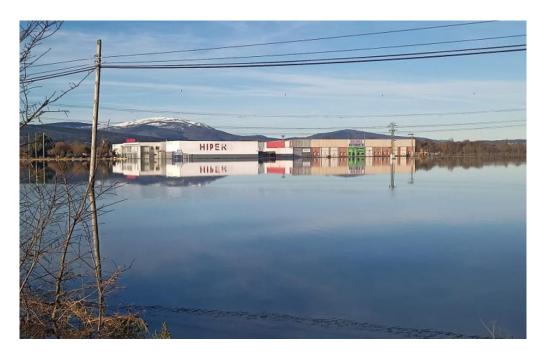
Figure 7. Factory premises in Vitoria. Source: CCS.

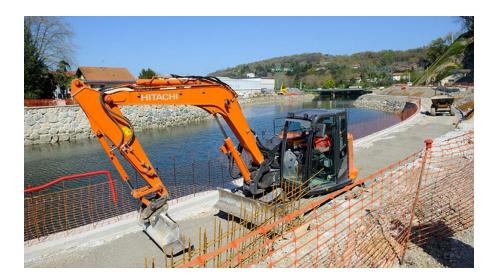
Figure 8. Civil hydraulic projects. Source: URA (Basque Water Agency).

These systems also enable corrective or preventive structural measures to be taken, such as, for example, the actions which the URA (Basque Water Agency) has implemented at problematic points in the various different basins within the Basque Country (Cadagua, Oria or Ibaizábal, to name a few), which have had a positive impact on diminishing the effects of these recent surge-based flooding incidents.

This also enables active reservoir management, the holding up of flows and substantially lowers the level which the water reaches and, by extension, water damage below reservoirs.

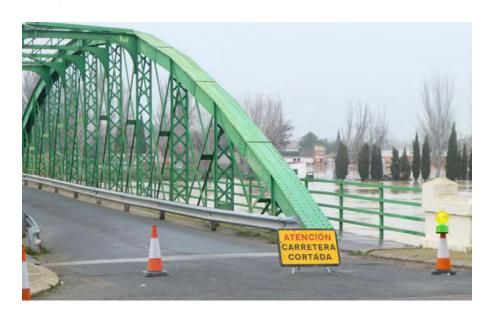
Figure 9. Bridge over the Ebro where it flows through Gallur (Z). Source: CCS.

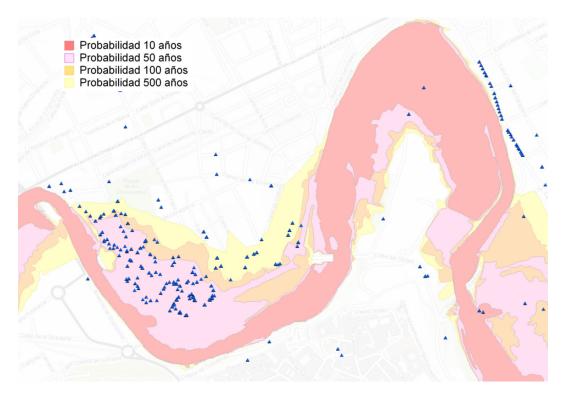
Figure 10. Claim files registered by the CCS and flood risk zones. La Rochapea Quarter, Pamplona.

We have been able to observe how the flood maps for this event have turned out to be very similar to the flood risk mapping drawn up in the context of the associated plans for managing this particular risk. A good example is the map of claim files received by the CCS from across the La Rochapea neighbourhood in Pamplona (Figure 10), where we can note that most cases are in the flood area with a 50-year likelihood.
