Measures to improve the resilience of historical buildings

Case in point: The Royal Mint building in Segovia

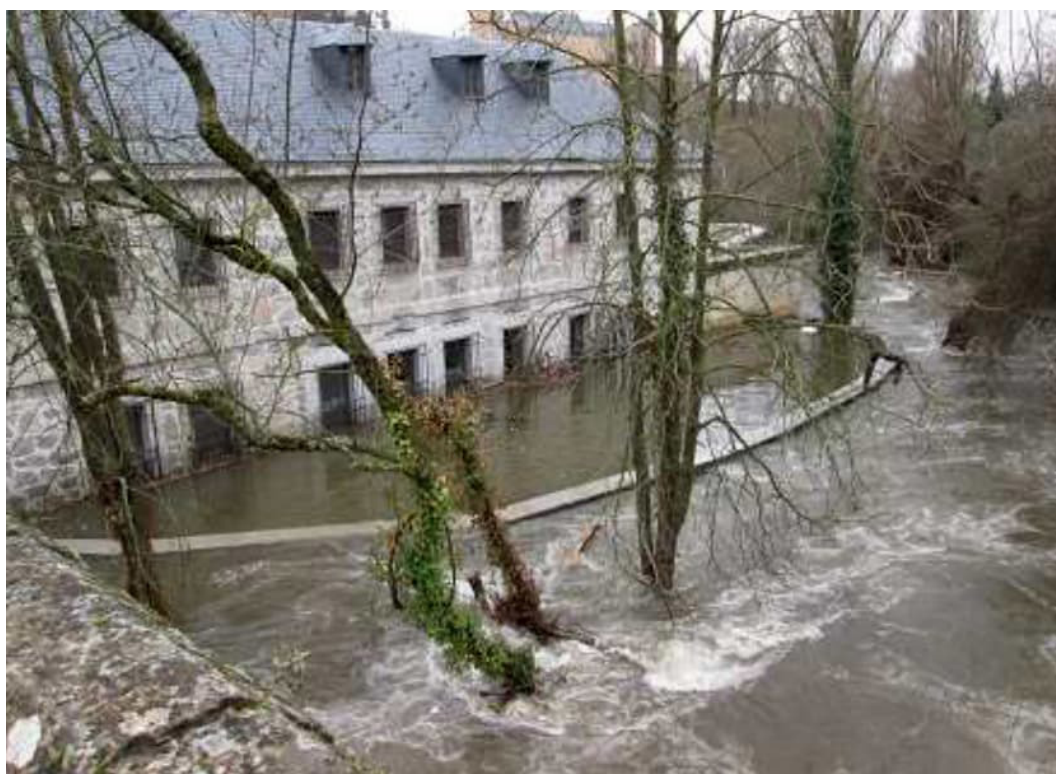
Figure 1. Terrace of the Royal Mint building in Segovia under water during the 2014 flood.

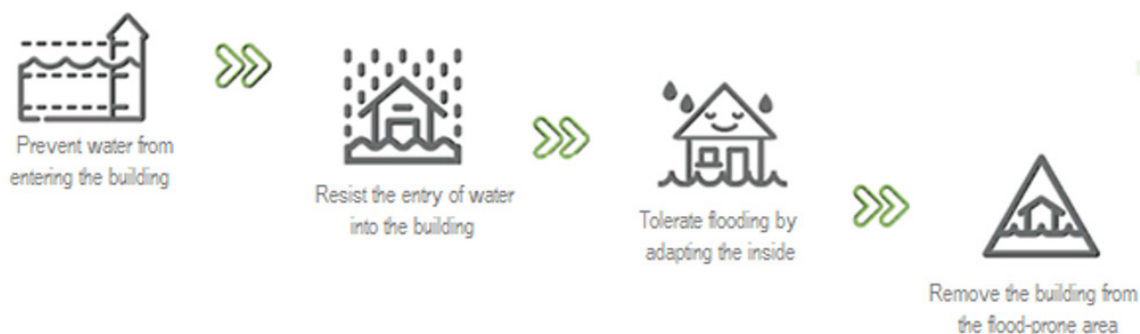
Figure 4. Self-protection strategies.
Source: Created by the authors.

There are four strategies:

- Avoidance: preventing water from coming near the building.
- Resistance: letting water reach the building but shielding the building to keep it from getting inside.
- Toleration: allowing water to enter the building while at the same time minimising vulnerabilities.
- Building removal (knocking down or moving the building).

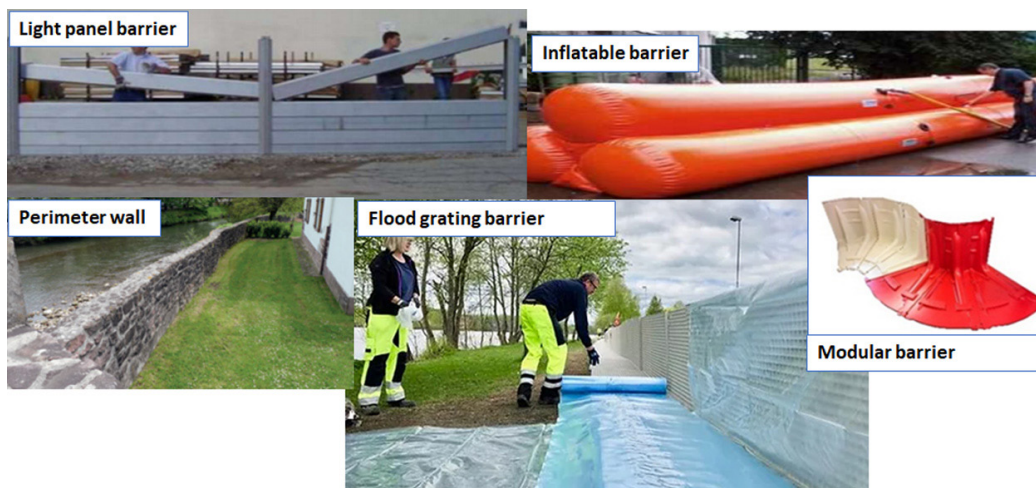
Figure 7. Most common AVOIDANCE strategy measures.
Source: Various sources.

The predominant **AVOIDANCE** strategy measures include building walls and erecting temporary aluminium-panel barriers and flood grating (light plastic-coated panels installed on the fly). Inflatable or modular barriers work very well for low budgets where flood water depth is low. Premium solutions include floodgates that rise automatically in response to by water pressure, but they are high-cost solutions that are only justifiable where damage is likely to be considerable, and they can be difficult to integrate into cultural heritage buildings.

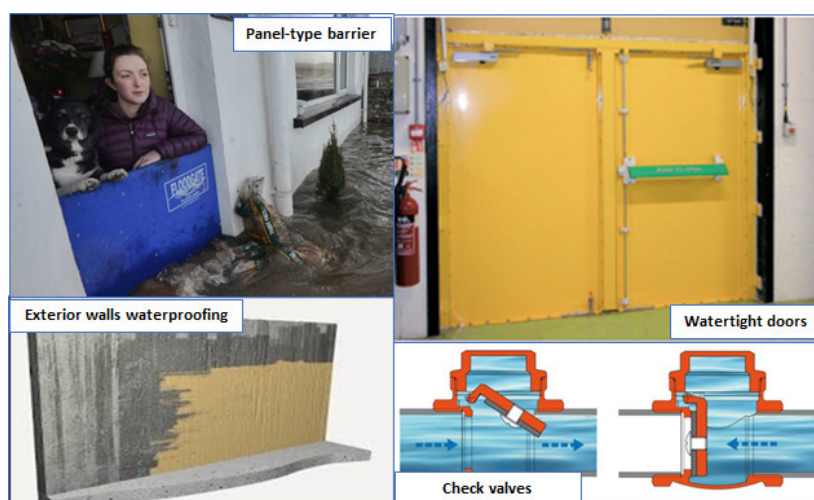
Figure 8. Most common RESISTANCE strategy measures.
Source: Various sources.

Predominant **RESISTANCE** strategy measures include waterproofing exterior walls against exposure to water, using temporary floodgate panel-type barriers to raise the thresholds of doors and windows, installing watertight doors and windows or check valves at pipe connection points to prevent water from entering through overflowing water supply and drainage systems, and temporarily sealing ventilation grilles. Measures involving permanent watertight doors and windows can be difficult to integrate into historical buildings.

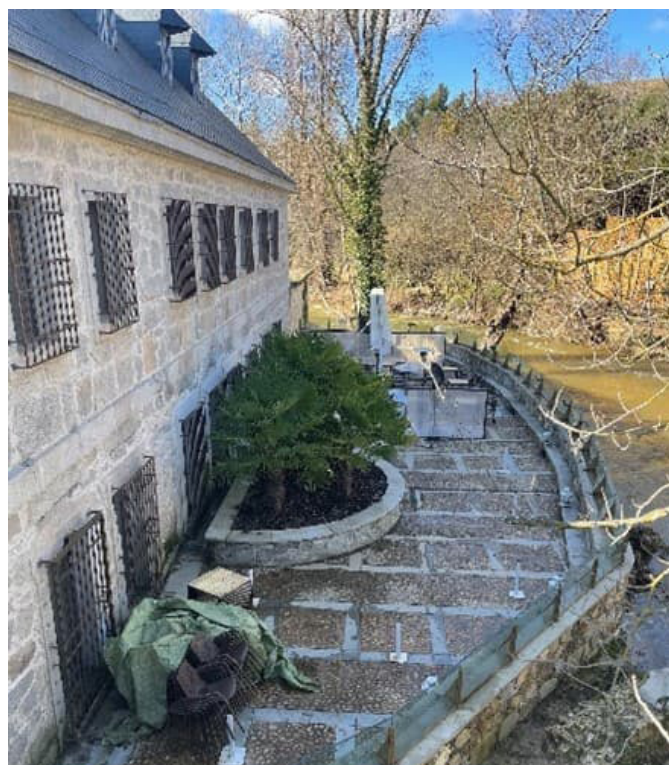
Figure 11. Cafeteria terrace bordering on the river channel.

- The inside of the drainage system was revamped.
- A 60 cm-high parapet was built on top of the brick wall surrounding the terrace of the El Ingenio Chico cafeteria, made of safety glass attached to the wall by a system of metal fasteners.

Some of these measures are in line with the proposals made below, but others, like the glass parapet along the terrace wall, can sometimes make the problem worse. In any event, they were not able to stop the damage from being repeated in 2020.

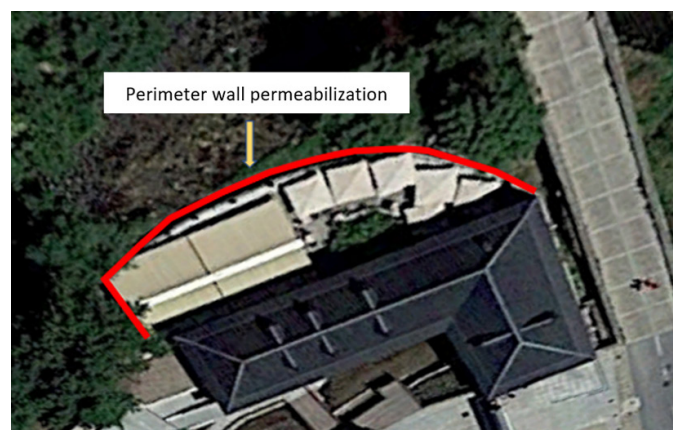
Figure 13. Measures in the terrace wall of the El Ingenio Chico cafeteria.
Source: Google Maps.

- **Water should be allowed to flow into the terrace of the El Ingenio Chico cafeteria** at a specified water height. At present the terrace wall has been raised by attaching transparent panels.

This is to be done by removing the glass parapet and replacing it with a steel railing or balustrade that will allow water to pass through. Another proposal is to simultaneously make small (0.25 x 0.5 m) openings in the wall at 2-m intervals to allow waters to spread out in that section and thus keep the river from reaching even higher depths in the area surrounding the Mint.

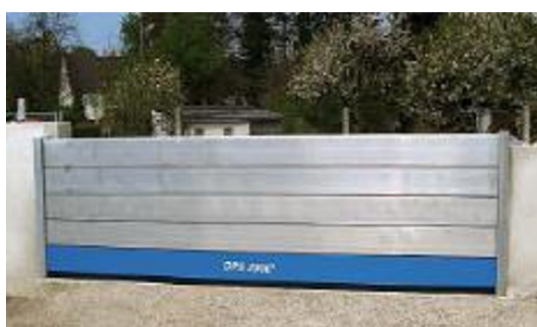
Figure 16. Modular floodgates for the main entrance doorway to the El Ingenio Chico cafeteria.
Source: CAG Canalizaciones S.L. catalogue.

- Installing temporary barriers at least 1.5 m in height in the doors and windows opening onto the cafeteria terrace as a back-up system to the (10+10) safety glass installed.
- Waterproofing the wall between the workshop and the channel with Bentofix, a controlled swelling material made of bentonite clay waterproofing geocomposites.
- Installing 10+10 glazing in the workshop windows opening onto the Eresma River and a back-up system of temporary (slim-line) flood barriers 1.2 m high from the window sill, to limit, or even prevent, the damage these rooms and the museum have suffered in past floods.

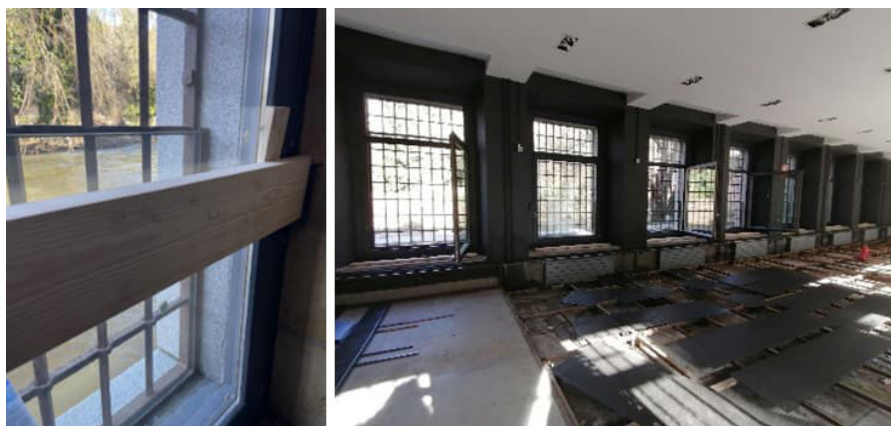
Figure 18. Detail of the existing reinforcement system for workshop windows.

- The wall between the workshop and the channel was waterproofed.
- Safety glass in metal frames was installed in the windows in the area where the workshop is located along with extra protection in the form of reinforcement with wooden boards to ensure that the windows can withstand the pushing of the waters and stay shut.

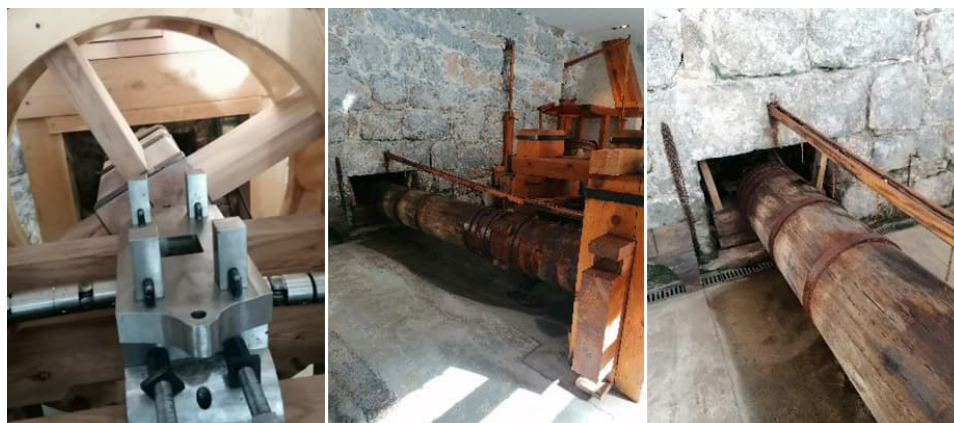
Figure 19. Museum machinery shafts.

- Installing an O-ring seal to prevent water from gaining entry through machinery shaft apertures.
- Waterproofing the lift pit and drainage system.
- Installing check valves at the pipe connection points for the water supply and drainage system and sealing the pipe grommets in the sump chambers.
