The cut-off lows of 2012 and 2019 in the south-east of the Iberian Peninsula

Consorcio de Compensación de Seguros

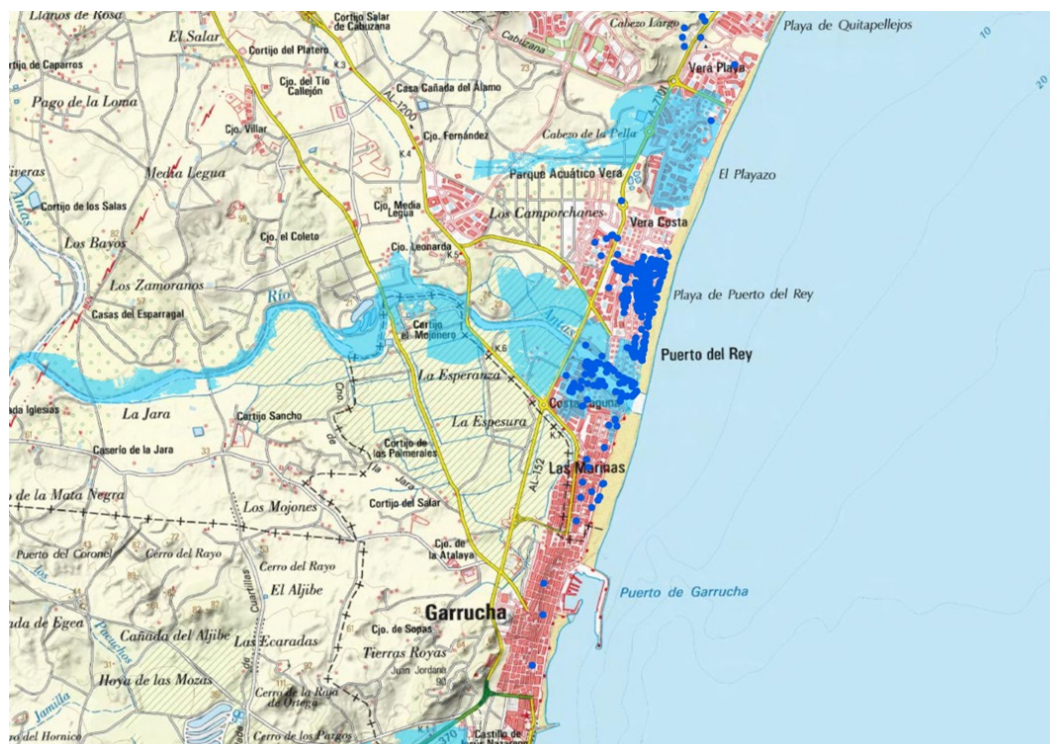
Figure 3: Overflowing of the river Antas at its mouth in Vera-Playa.
Sources: CCS and SNCZI.

The worst affected province was Almeria, with 3,625 claims applications and a total amount of 75.1 million euros. The intensity of the damage in this province, at an average indemnified sum of 20,700 euros, is far higher than for the other zones. It is in the municipal district of Vera (in Vera-Playa to be precise) where most of the claims experience was focussed, with a little over 2,000 claims, 58.3 million euros in pay-outs and a very high average sum indemnified of close to 29,000 euros. In Vera-Playa the river Antas burst its banks along its last section (Figure 3), which provoked serious damage to the housing developments near its course, with hundreds of homes evacuated and businesses brought to a standstill, as well as to the vehicles in the area, most of which proved beyond recovery (Figure 4).

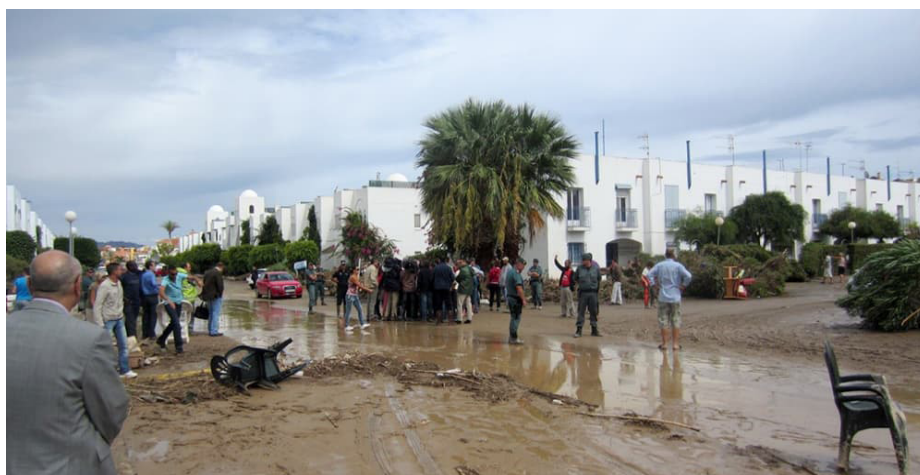
Figure 4. Flooded zone in Vera-Playa.

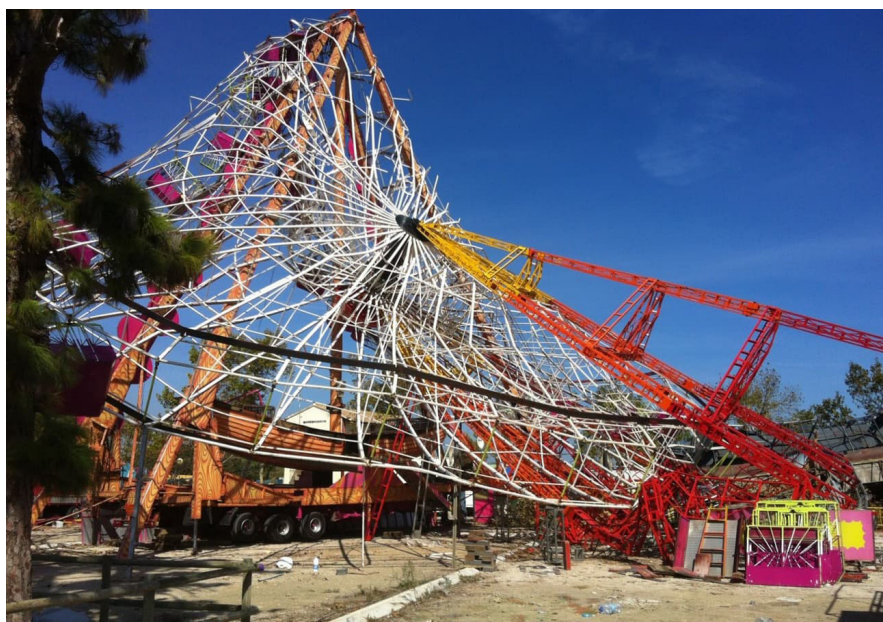
Figure 5. Tornado damage at the Gandía fairground.

Although most of the indemnities paid out were for flooding, it is worth mentioning that there was a tornado on 28 September associated with severe convection from the cut-off low itself in the municipal districts of Gandía and Xeraco (Valencia), which triggered 1,226 claims applications and pay-outs totalling 8.7 million euros (Figure 5).

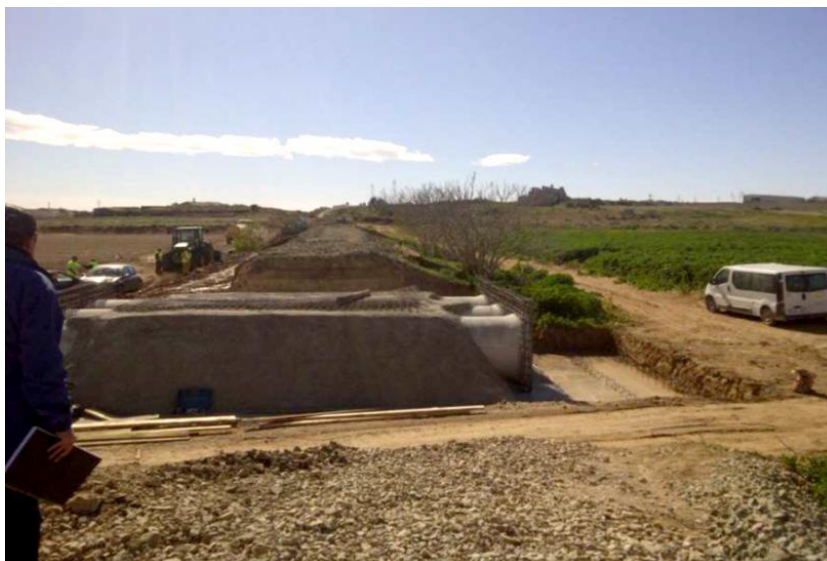
Figure 7. Execution of new drainage works on the Murcia-Águilas railway line due to shifting of drainage channels following the 2012 flooding.

As a result of the heavy and persistent flooding, the Guadalentín plain experienced changes to drainage channels accompanied by some examples of the damming effect caused by linear civil works, as in the case of the Murcia-Águilas railway line as it runs through the station at Puerto Lumbreras (Figures 7 and 8).

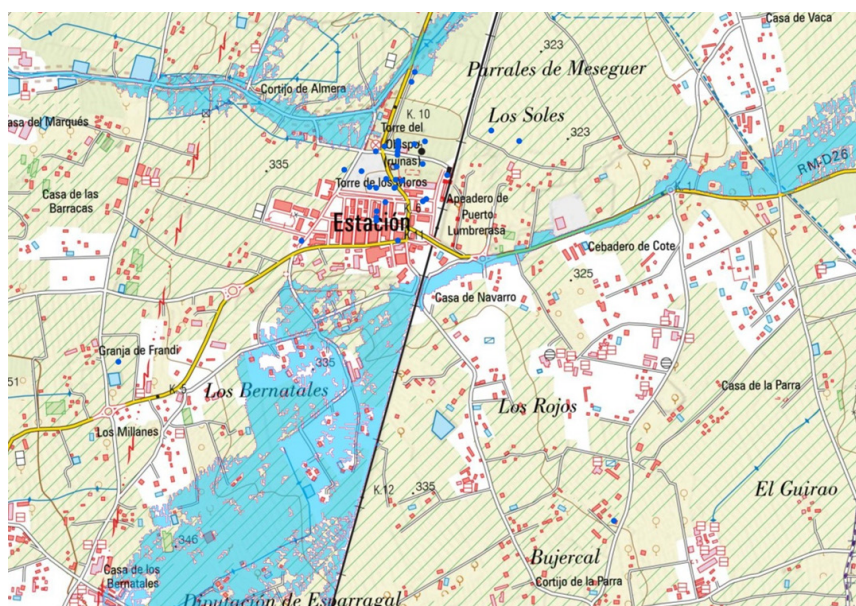
Figure 8. Damming effect at the Puerto Lumbreras station caused by the Murcia-Águilas railway line and the flooding of properties located upstream.

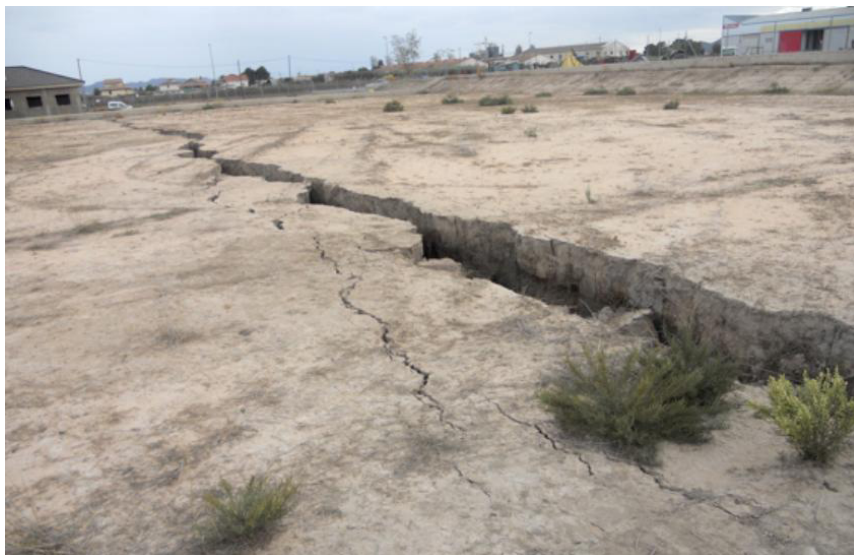
Figure 9. Piping phenomenon at the Los Soles spot in Puerto Lumbreras station.

At Puerto Lumbreras station, which belongs to El Esparragal council, and on the industrial estate of El Saladar de Totana sub-surface or piping erosion phenomena occurred, which consist of the formation of ducts and conduits from erosion provoked by the groundwater on certain areas of land which lend themselves to dispersal. In certain cases, the piping caved in and cracks emerged on the surface, as we can see in Figure 9.

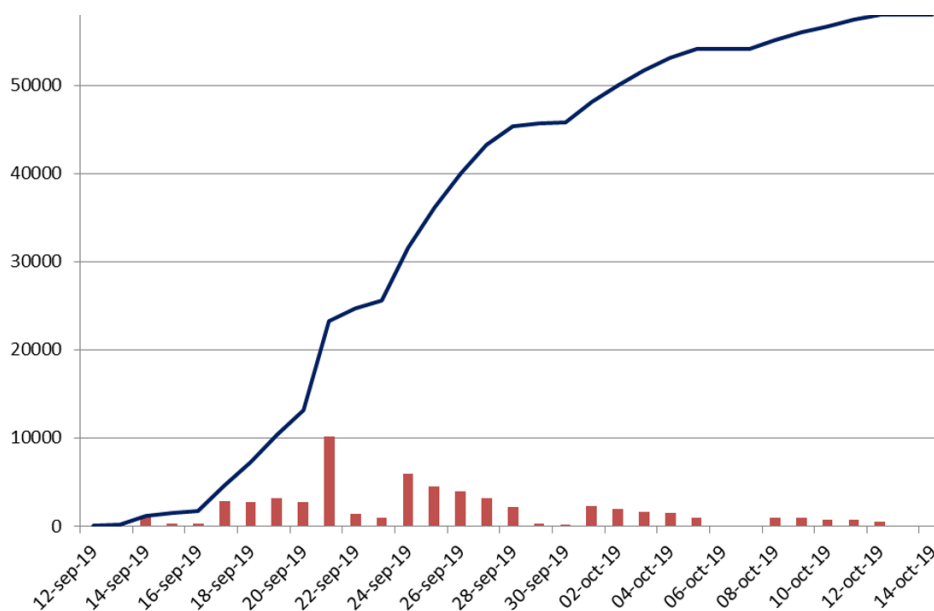
Figure 10. Number of daily claims applications received (red bars) and cumulative claims (blue line) received by the CCS in the 33 days following the occurrence of initial damage.

Because the area affected was so enormous, the CCS immediately commissioned 18 reports on the loss rate from adjusters in the various different zones to be in a position to be able to have estimated figures to hand right from the start on the magnitude of the disaster and to scale both the adjuster network and the team of claims handlers. As a result of this cut-off low the CCS received around 70,000 claims, 58,000 of which were filed in the 33 days from Tuesday 11 September to Sunday 13 October 2019, numbers peaking at 10,175 on 18 September 2019 (Figure 10).

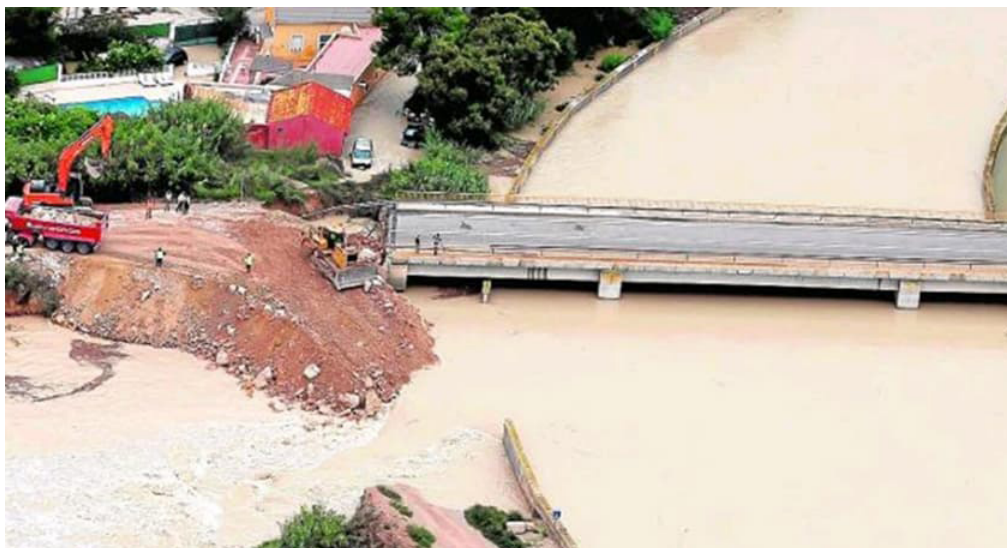
Figure 12. Breakage of the channelling of the river Segura at Almoradí.
Source: Segura River Basin Authority.

One of the hardest hit zones was La Vega Baja del Segura, with nearly 22,000 claims applications and pay-outs amounting to 185.2 million euros. Specifically, Orihuela saw the most damage, with 56% of indemnities for the entire administrative division. The flooding in this zone was exacerbated by the breaking open of one or two dykes and, above all, the channelling for the river Segura on its left bank level with Almoradí.
