The Lorca earthquake: Lessons for reconstruction

Ramón Cabal Álvarez

INTEMAC, Universidad Politécnica de Madrid

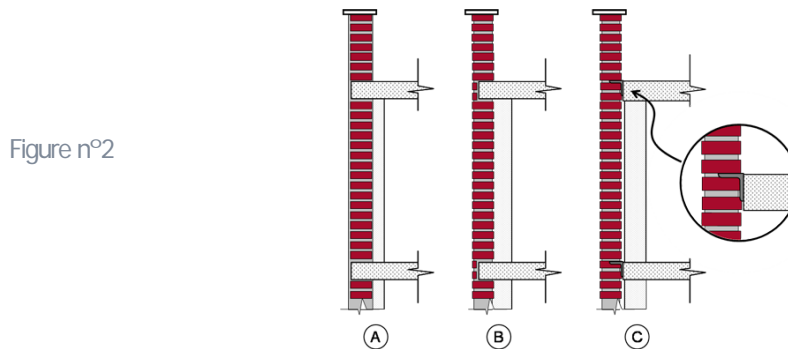
The sole variable in the standard construction arrangements in Spain shown in Figure 2 is the position of the masonry with respect to the floor slab. Since the nineteen fifties when the panes rested fully on the slab (Figure 2 A), other solutions have been developed, such as the partially supported façades (Figure 2 B) often seen today, and attachment to steel brackets (Figure 2 C). A variation on the third approach, very common when the pane is not upwardly continuous, consists of securing the bracket to rods hung from the floor slab (Figure 3 and photograph 8)

This wholly inappropriate solution, unable to resist any horizontal action, was used in many of the roof parapets that collapsed during the Lorca earthquake. The severest problem, however, is that this is not the only hazard.

Actually, none of the arrangements depicted in Figure 2 (which illustrates the construction set-ups used in practice) can guarantee pane stability when exposed to the minimum horizontal actions defined in construction codes.
