The August 1983 floods in the Basque Country: events and lessons

José María Sanz de Galdeano Equiza Director of Planning and Works

Aitziber Urquijo Luengo Head of Hydraulic Works Agencia Vasca del Agua URA [Basque Water Authority]

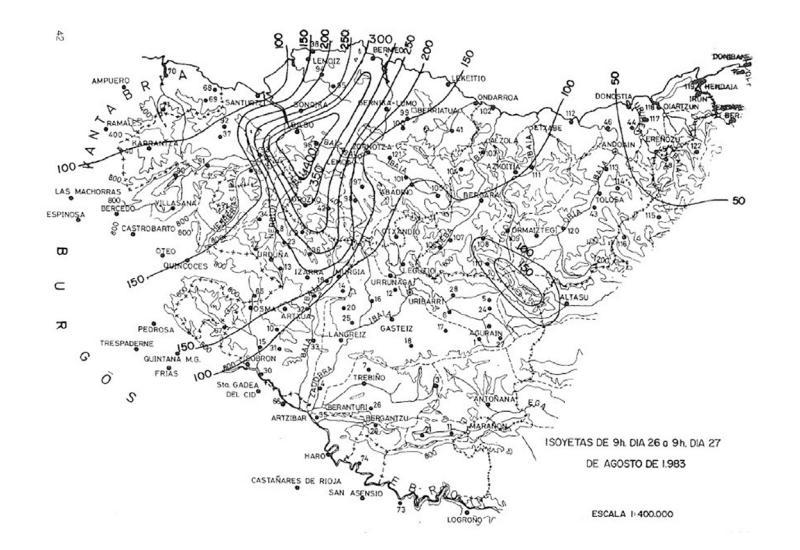
Figure 1. Rainfall from 9:00 a.m. on 26 August to the same time on 27 August 1983. Source: Biscay Provincial Council, 1984: "Torrential rains. August 1983: Quantifying the Disaster". These two rivers in fact form a single river basin system that empties into the ocean at the Bilbao estuary. According to reports, the most precipitation fell not at the headwaters but in the middle and lower courses where the two rivers meet and some kilometres upriver. The rainfall was so heavy and so concentrated in these sections just above the industrial centres of Galdakao, Basauri, Etxebarri and Bilbao itself that swells arrived abruptly and simultaneously with no time or space for any natural flood abatement to occur. This took place on river plains that had furthermore, been hemmed in and built up thanks to urban industrial and residential development on lands stolen from the rivers.

The rain came down hardest right in the Nervión and Ibaizabal river basins and in the area between them and the coast of Biscay. In particular, upriver from Bilbao around the junction of the Nervión and Ibaizabal rivers and a broad swath spreading out towards the Mungia region and the coast between Bermeo and Gernika. In this small area over 200 mm were recorded between 9:00 a.m. on the morning of the 26th and the same time on the 27th, spiking to over 400 mm between the junction of the Nervión and Ibaizabal rivers and Bilbao.

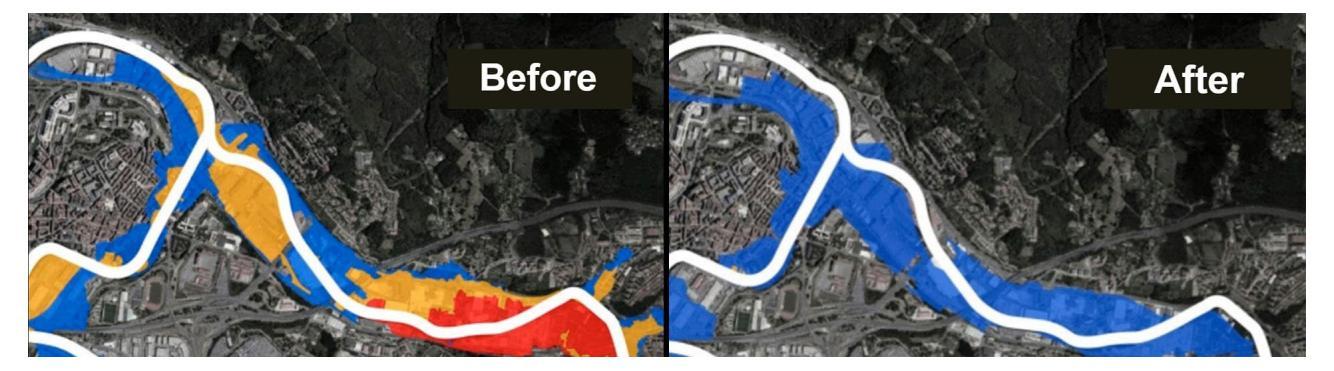
Figure 2. Flood-prone areas before and after the management work to the Ibaizabal River. In blue, by 500-year floods; in yellow, by 100-year floods and in red, by 10-year floods. Source: Basque Water Authority.

Bilbao is obviously still a high-risk area. Some storm tanks have been built and more particularly the city government has dug a canal through the former Zorrozaurre peninsula, making it into an island. The result is a one-metre drop in water level in the area subject to 500-year flood events and progressive abatement upriver, so levels drop in the vicinity of City Hall and do not reach the Old Town, where the worst flooding occurred in 1983. There is no easy fix, because the river has been boxed in. A proposal to build tunnels to drain off some of the water from higher up above Bilbao into the estuary below the city has been made. However, the plan is not yet ripe, and before it can be put into effect, there are uncertainties and issues that first need to be addressed, including hydrological considerations, and not least its extremely high cost. In contrast, work to renovate management measures on the Nervión is under way at Llodio, where some of the first management works were built but proved to be inadequate. In addition, 11 years after the first stage was started, the third stage of work to improve the Ibaizabal to one kilometre downriver from the junction with the Nervión has just been completed at Galdakao, at a total cost of 36.2 million euros.

A population of some 5,200 people who were affected by the 100-year flood lives in the management area. The intent is to make the river channel capable of draining off those flood waters so that hypothetically at least no-one in that area would now be affected by a flood event of that kind. The average annual damage to be expected in the area that would be affected by a 500-year flood is now estimated at around 0.7 million euros, down from the 7 million euros estimated before the work was carried out. It is thus apparent that the work would pay for itself in just six years. From that point on, everything would be net profit depending on the estimated average annual amount of damage. So works of this kind bring tremendous benefits.

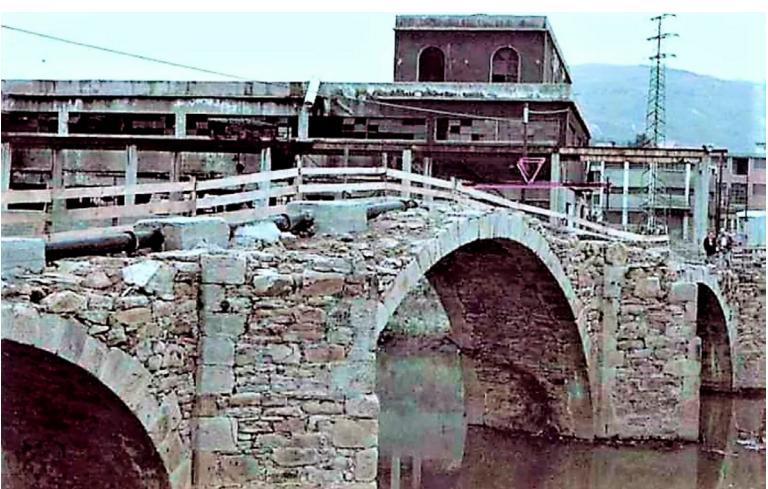
Figure 3. The Mercadillo Bridge in Galdakao after the August 1983 floods. The height attained by the water is clearly visible. Source: Biscay Provincial Council, 1984: "Torrential rains. August 1983. Quantifying the Disaster".

The third stage of the work on the Ibaizabal also exemplifies one of the Basque Water Authority's design objectives: to protect, and indeed preserve, the cultural heritage present in the section where the work is carried out. In this case the Medieval Mercadillo Bridge was a conspicuous barrier to flood waters and in point of fact was in peril of being swept away by the 1983 flood. Therefore, an alternative channel was built bypassing the bridge and in addition the river bed generally has been widened so that the high water can continue to pass under the bridge, no longer a barrier to flow. Not only that, the bridge has been restored under the direction of the Spanish Cultural Heritage authorities.

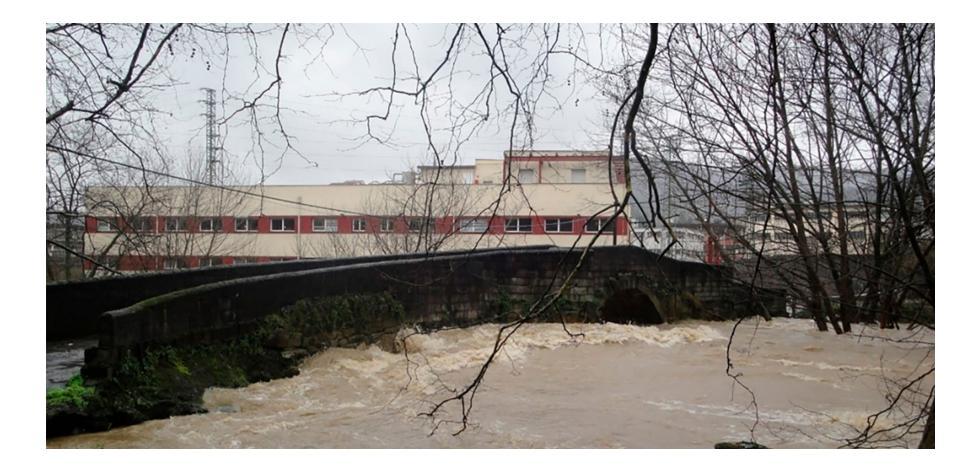
Figure 4. The Mercadillo Bridge during a flood event prior to the management work and before being restored. Source: Basque Water Authority.

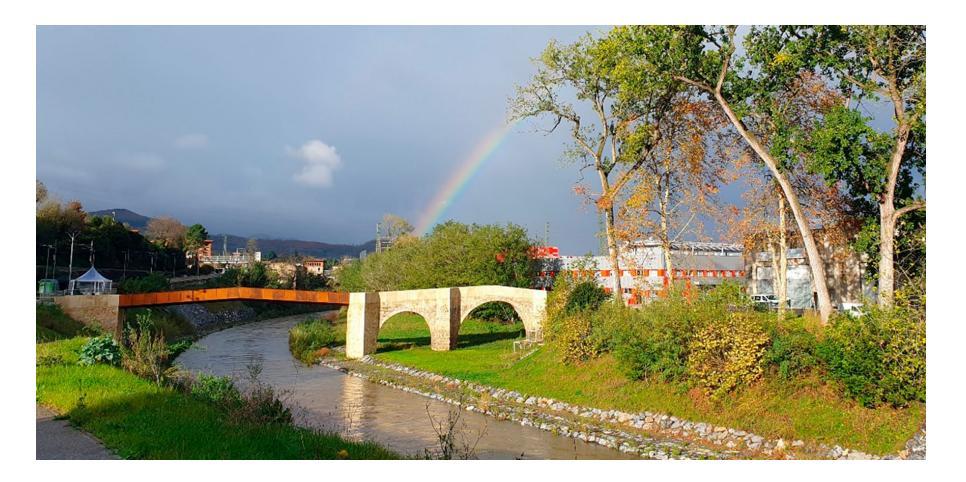
Figure 5. The Mercadillo Bridge in Galdakao after the work was completed. Source: Basque Water Authority.

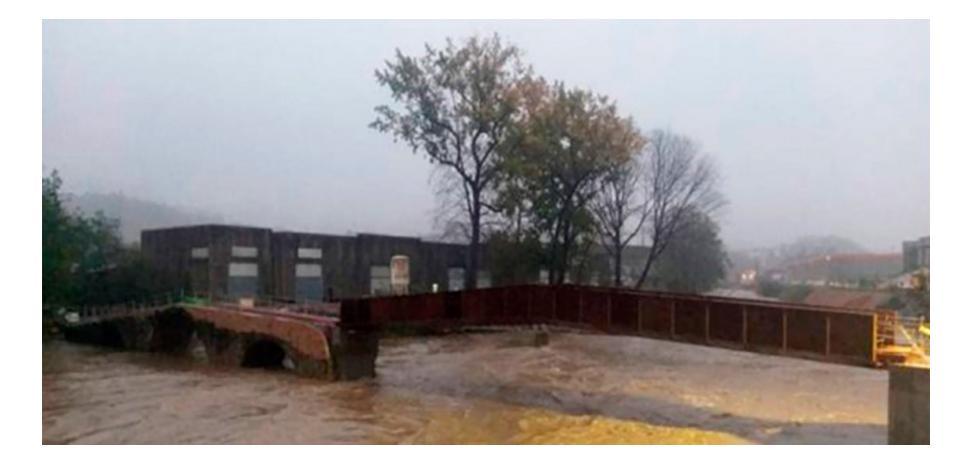
Figure 6. The Mercadillo Bridge during a flood in December 2021, operating with unfinished works. Source: Basque Water Authority. In other cases, like Vitoria-Gasteiz on the Zadorra River, or the management work on the Cadagua River in Zalla (Biscay), the objective has been to bring the floodplain back to its former natural ecological conditions insofar as possible based on old aerial photographs to replicate the previously existing flood abatement areas that had been filled in, so that they can once again be flooded and in that way help abate flooding and lessen risk in places where until now flooding had posed a threat to the inhabitants. These improvements have taken nearly 2,000 people out of the reach of 100-year floods at a cost of around 10 million euros.

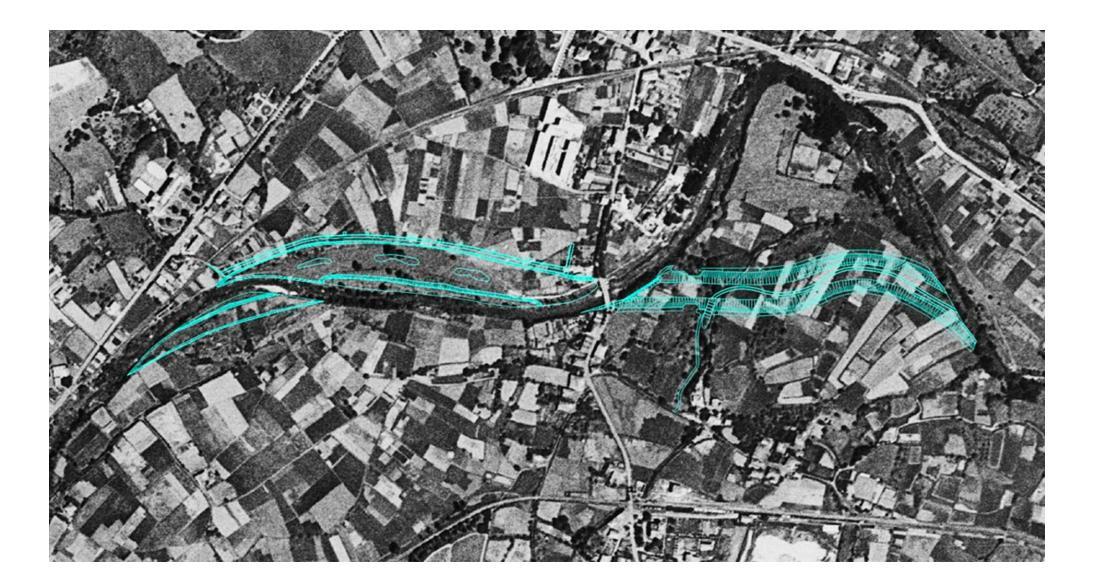
Figure 7. Old aerial photograph of the Cadagua River in Mimetiz (Zalla) with the areas to be recovered to receive flood waters drawn in. Source: geoEuskadi viewer and the Basque Water Authority.

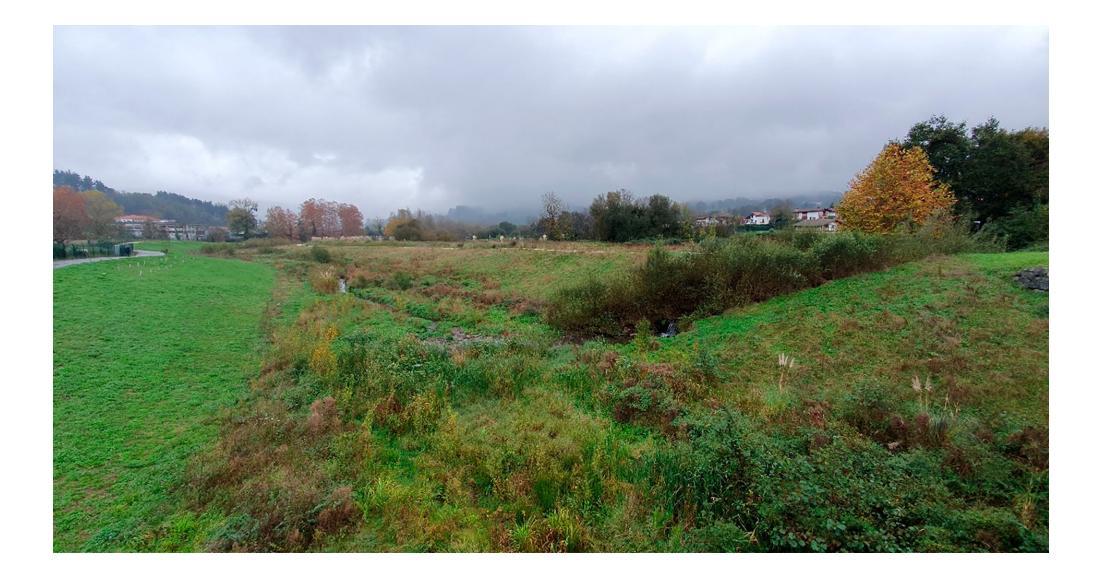
Figure 8. Additional water channel and recovered floodplain by the Cadagua River in Mimetiz (Zalla). Source: Basque Water Authority.

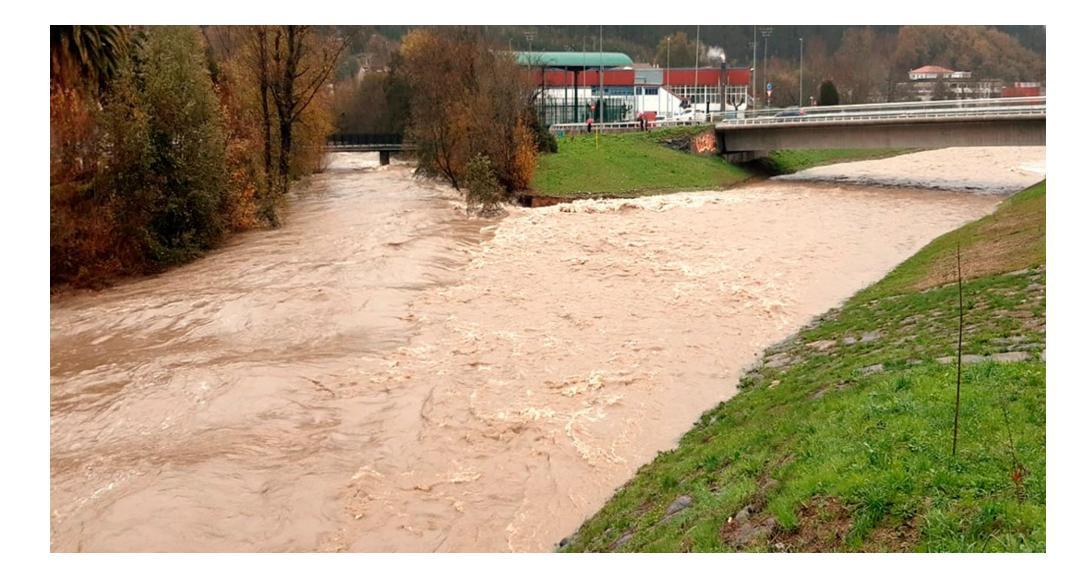
Figure 9. The Cadagua River during a flood with the recovered floodplain acting as an additional channel. Source: Basque Water Authority.
